LAKE HANNIBAL ESTATES UPPER DAM

RALLS COUNTY, MO.

MO 11185

**PHASE 1 INSPECTION REPORT
NATIONAL DAM SAFETY PROGRAM**

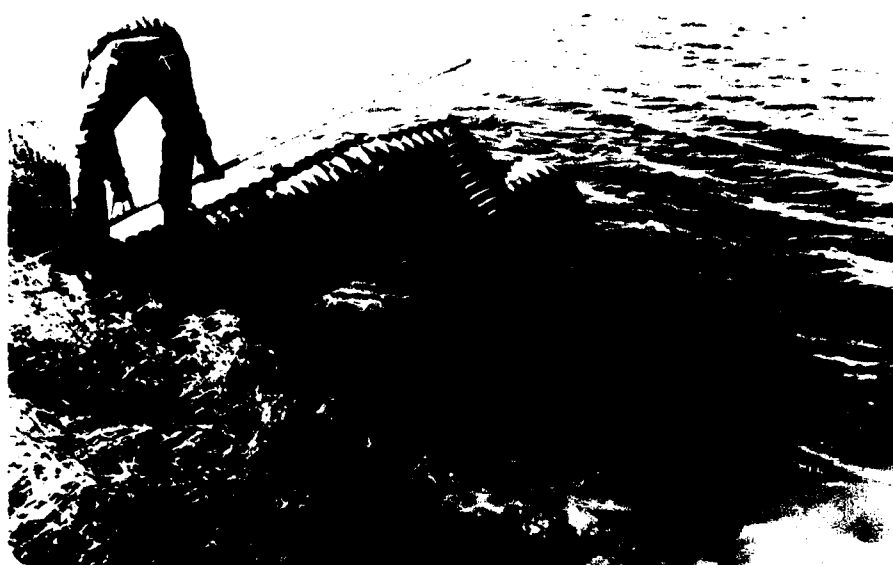
Rotation of the "gooseneck" type inlet to its highest invert elevation of 99.0 would result in the spillways not being able to pass the 10-year flood without overtopping the dam. Failure of the spillways to pass the 10-year flood would change the classification of the dam from Unsafe-Non-emergency to Unsafe-Emergency.

- (a) Inlet Structure. The "gooseneck" type inlet is constructed of 24-inch diameter corrugated metal pipe and is attached to the inlet end of the conduit by a 24-inch length corrugated metal pipe band with manually tightened bolts. The effective invert elevation of the inlet can be raised by loosening the bolts and rotating the inlet. The "gooseneck" type inlet is shown in Photo No. 6.

PHOTO NO. 6 - PRINCIPAL SPILLWAY INLET WITH ADJUSTABLE HOOD.

- (4) Measures should be taken to assure that the elevation of the invert of the principal spillway inlet does not exceed 97.0.
- (5) Maintenance of the vegetation on the embankment and emergency spillway is excellent and should be continued.
- (6) A trash rack should be installed on the principal spillway inlet to help in keeping the spillway open.
- (7) Periodic inspections of the dam should be made and recorded as part of this project file.
